Site Inspection Report Liquid System

Contractor:	Project I.D No:	Project Name/Title:
Belmont Roofing	4421	The Theatre Royal

Date: 17/9/14

Visit No: 2

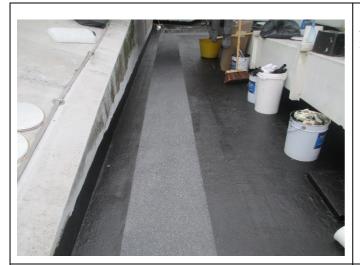
Anti-slip walk way has been installed on top of the Eurocote SPO Base Coat. Awaiting the Top Coat over full area.

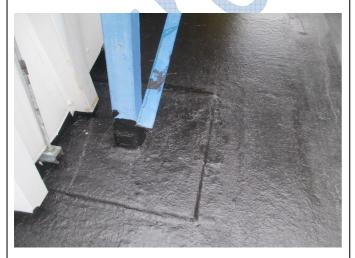
Eurocote SPO has been applied to the existing substrate and coverage has been achieved.

Eurocote SPO Base Coat has been applied to the detail work to a good standard.

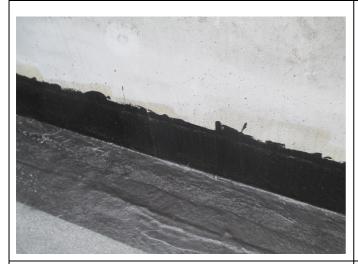
Coating has been dressed 150mm up the upstand detail.

Good application work around detail.

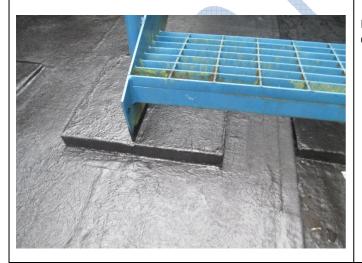
Detail work on the roof in which the Eurocote SPO Base Coat has been applied to a good standard.

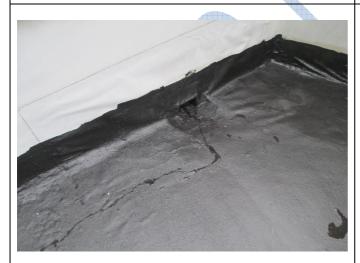
New outlet has been installed and the Base Coat has been applied to a good standard.
