BELMONT ROOFING LTD

CASE STUDY

OVERFLOWING GUTTERS TO FACTORY

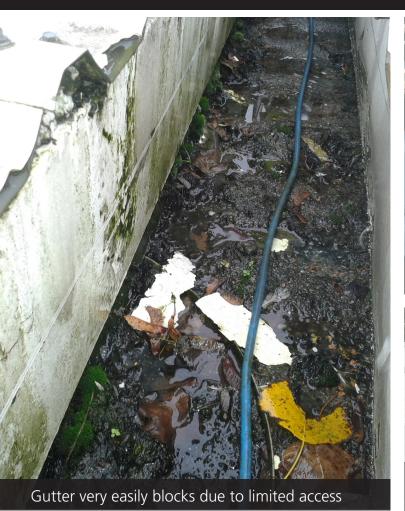
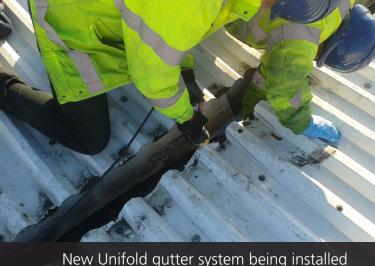
The roof has been over-clad and there is little room to easily access the gutter for cleaning etc

The Problem: Gutters overflowing during very heavy rainfall. The existing asbestos roof had been over-laid restricting easy access for cleaning and maintenance.

There was space available in the void below the roof sheets and the steelwork to increase the overall gutter dimensions.

The Solution: Full design calculations carried out by Belmont design team and Ampteam Ltd and the introduction of a purpose- made "Unifold" gutter lining system reinforced with an EPDM membrane.

This system is particularly useful in refurbishment work as it has a unique "hinge" system which is designed to allow retro-fitting below overhanging roof sheeting. The space within the void was maximised and allowed the work to be carried out without disturbance to the customers' business operations.
