BELMONT ROOFING LTD

CASE STUDY

OVERFLOWING GUTTERS TO FACTORY

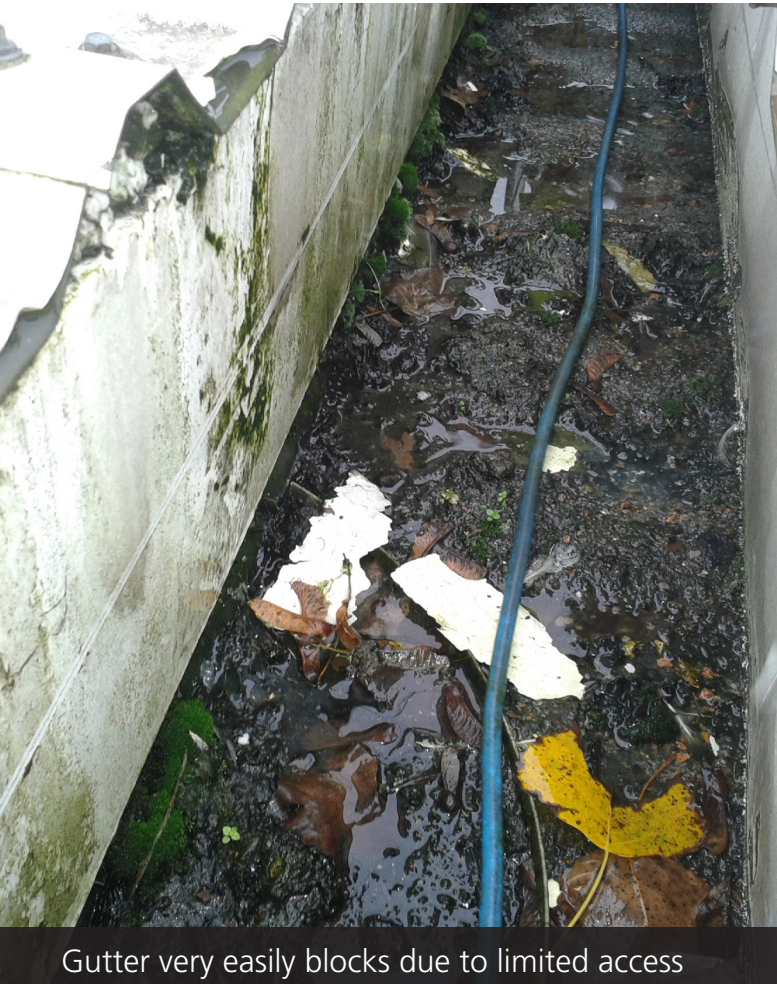
Gutter very easily blocks due to limited access

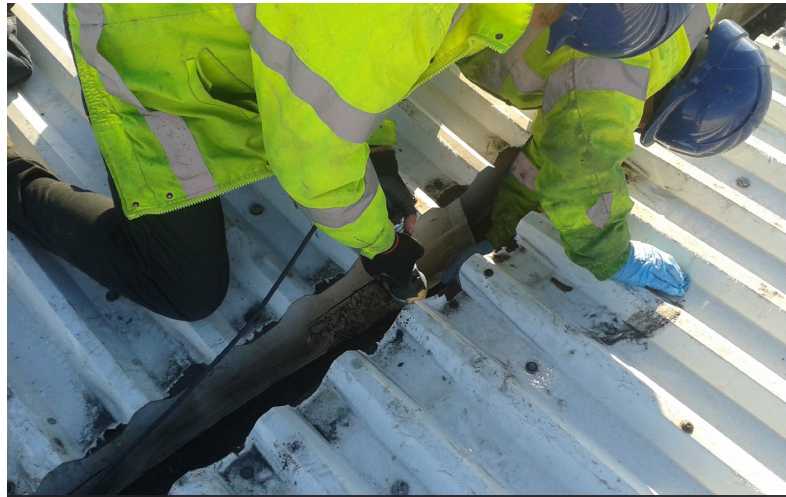
New Unifold gutter system being installed

The Solution: Full design calculations carried out by Belmont design team and Ampteam Ltd and the introduction of a purpose- made "Unifold" gutter lining system reinforced with an EPDM membrane.

This system is particularly useful in refurbishment work as it has a unique "hinge" system which is designed to allow retro-fitting below overhanging roof sheeting. The space within the void was maximised and allowed the work to be carried out without disturbance to the customers' business operations.

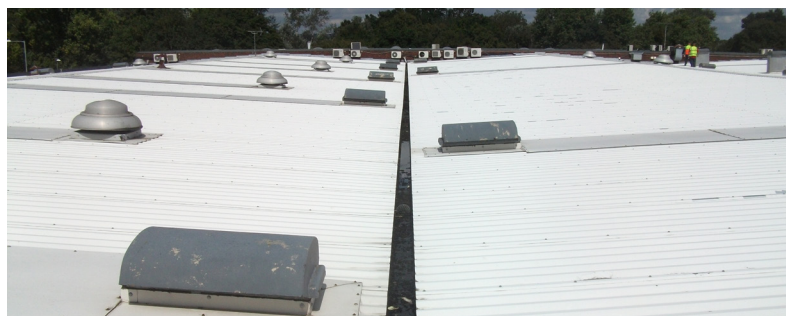
The roof has been over-clad and there is little room to easily access the gutter for cleaning etc
