## Overflowing Gutters to Factory.

**The Client:** Waymade PLC

**Value of Project:** £13,000

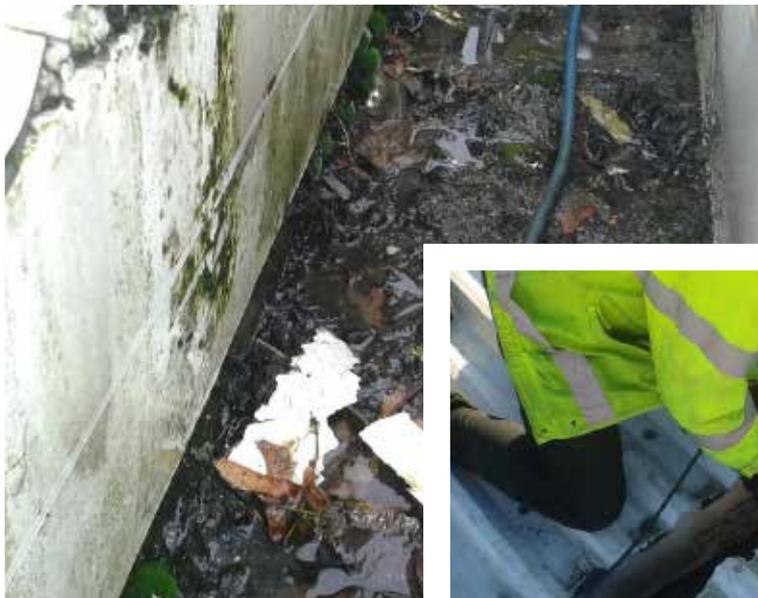
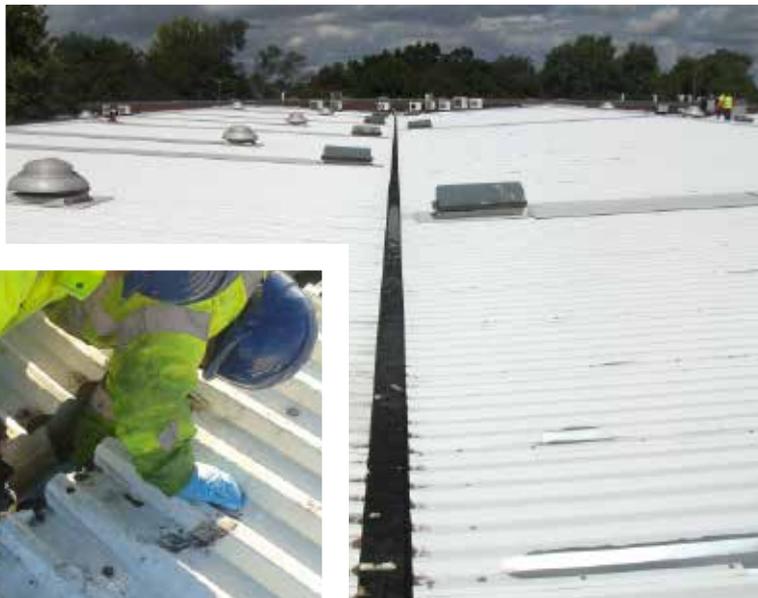
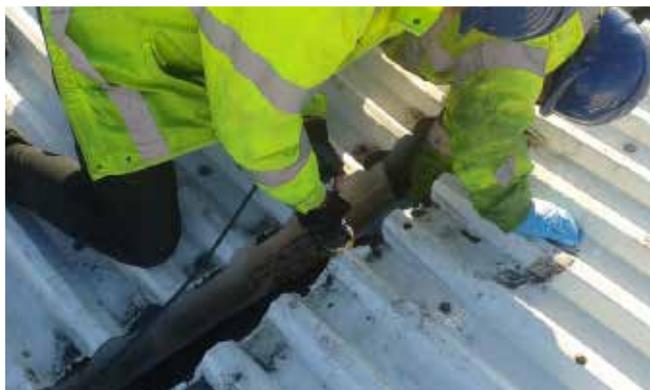
**The Problem:** Gutters overflowing during very heavy rainfall. The existing asbestos roof had been over-laid restricting easy access for cleaning and maintenance. There was space available in the void below the roof sheets and the steelwork to increase the overall gutter dimensions.

**The Solution:** Full design calculations carried out by Belmont design team and Ampteam Ltd and the introduction of a purpose-made "Unifold" gutter lining system reinforced with an EPDM membrane.

This system is particularly useful in refurbishment work as it has a unique "hinge" system which is designed to allow retro-fitting below overhanging roof sheeting. The space within the void was maximised and allowed the work to be carried out without disturbance to the customers' business operations.
